Sustainable Energy and Climate Action Plan 2021-2030

Ivano-Frankivsk National Technical University of Oil and Gas

Project HUSKROUA/1702/6.1/0075
“Cross-border network of energy sustainable
universities (NET4SENERGY)”

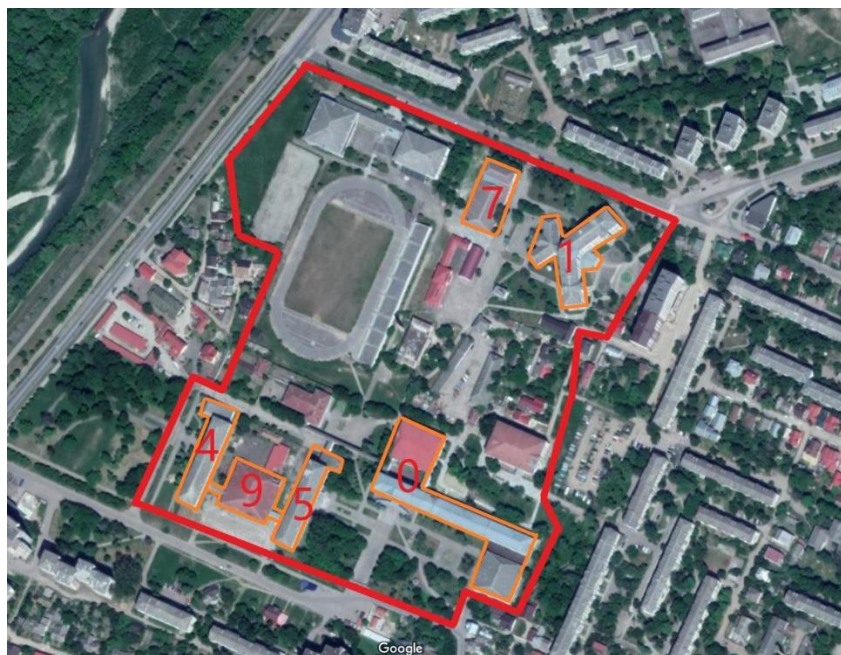
Figure 1 General map of the university buildings

A map of the main territory of IFNTUOG with an indication of the buildings that will be considered in the project is shown in Figure 1.

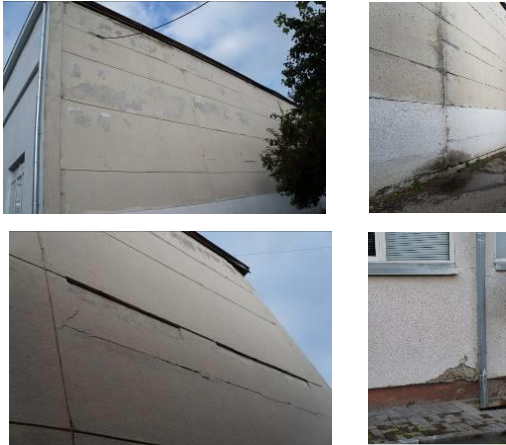
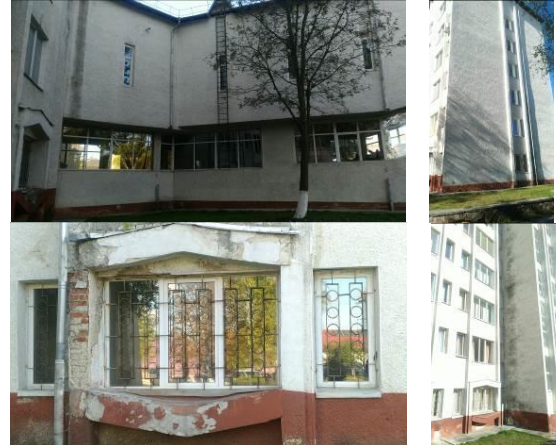
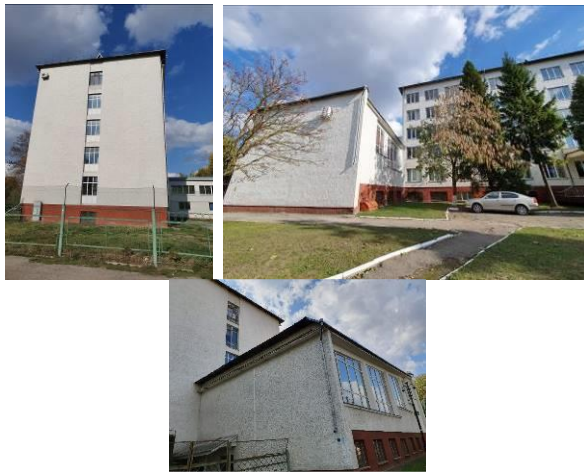
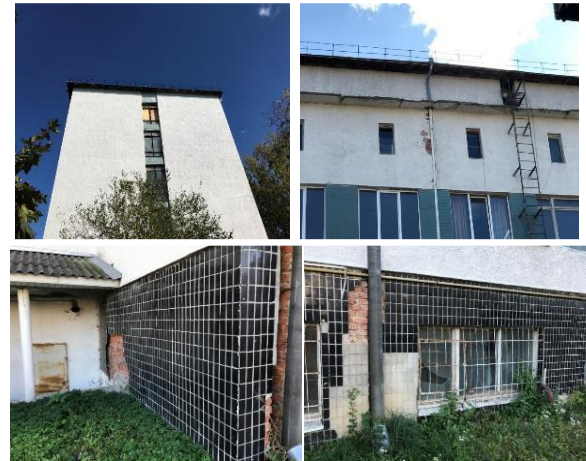
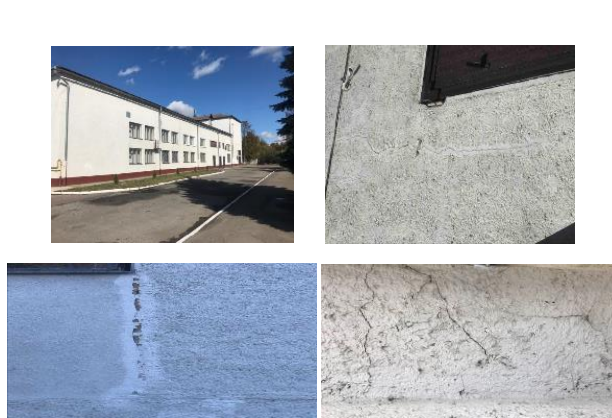
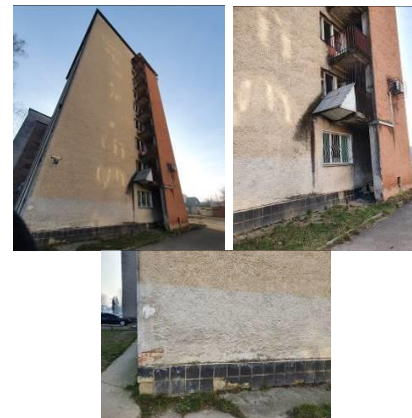
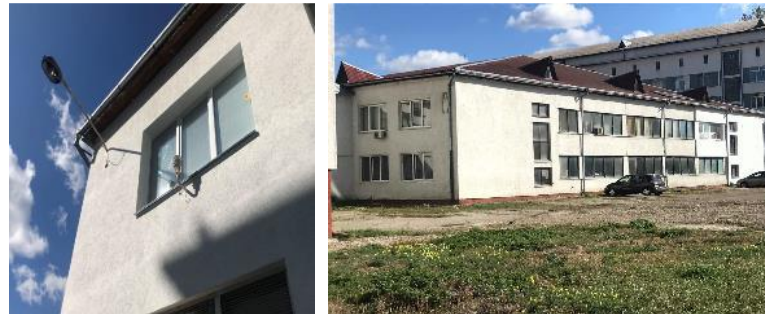
The walls of the building are in satisfactory condition, but the thermal characteristics of the walls do not meet regulatory requirements. There is a need for thermal modernization of existing wall structures.

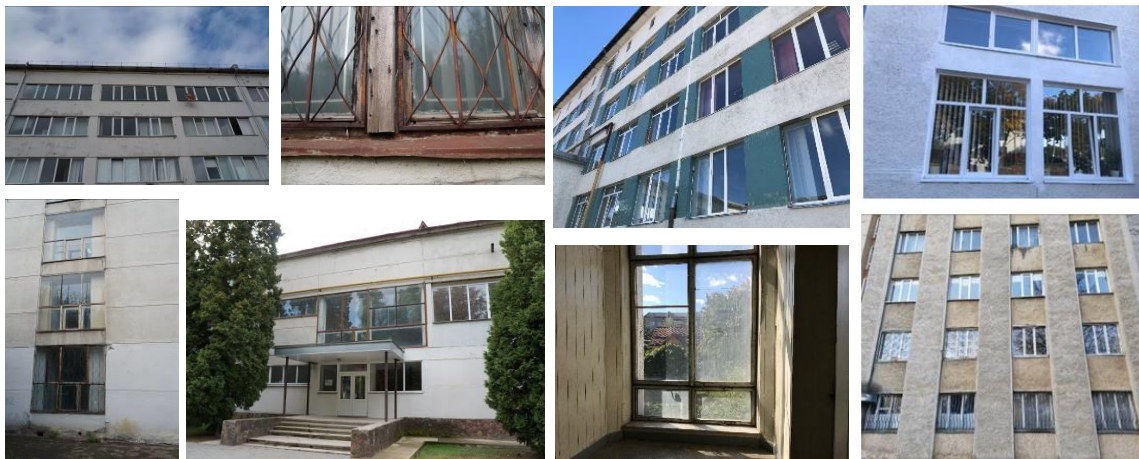
Figure 16 General view of the university buildings' windows

The windows of the building are in satisfactory condition. Most windows are replaced by metal-plastic, but their thermal characteristics do not meet the established requirements. A small number of windows have wooden and metal frames.

The existing windows and doors are in satisfactory condition with low energy performance; therefore, it is proposed to replace them.

Current average U-value of existing windows are evaluated as 2,38-2,56 W/m²K, while according to the current Ukrainian regulations the U-value of windows should be maximum 1,33 W/m²K.

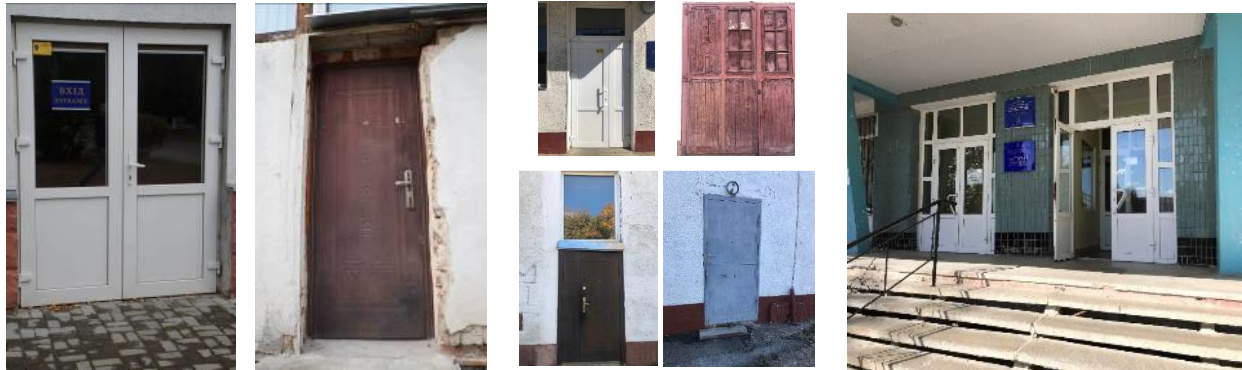
Figure 17 General view of the university buildings' doors

The general condition of the door is satisfactory. Most doors have been replaced with metal-plastic ones, but their thermal characteristics do not meet the normative values. It is necessary to provide a complete replacement of existing entrance doors in accordance with regulatory requirements.

Current average U-value of existing outer doors are evaluated as 2,56 W/m²K, while according to the current Ukrainian regulations the U-value of outer doors should be maximum 1,66 W/m²K.

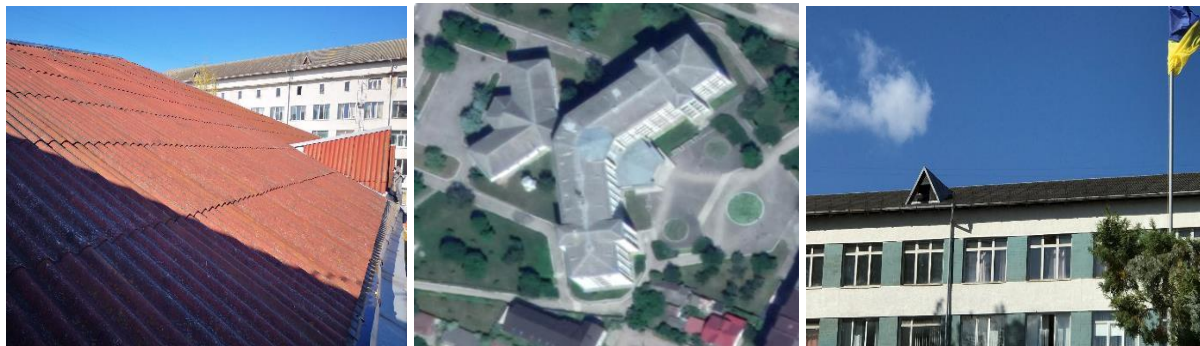
Figure 18 General view of the university buildings' roofs

All buildings have an unheated attic. the floor between the attics and heating rooms is not insulated. The technical condition of the floor is satisfactory. The technical condition of the roof over the attic is not satisfactory, cracks have been identified through which atmospheric moisture enters the attic.

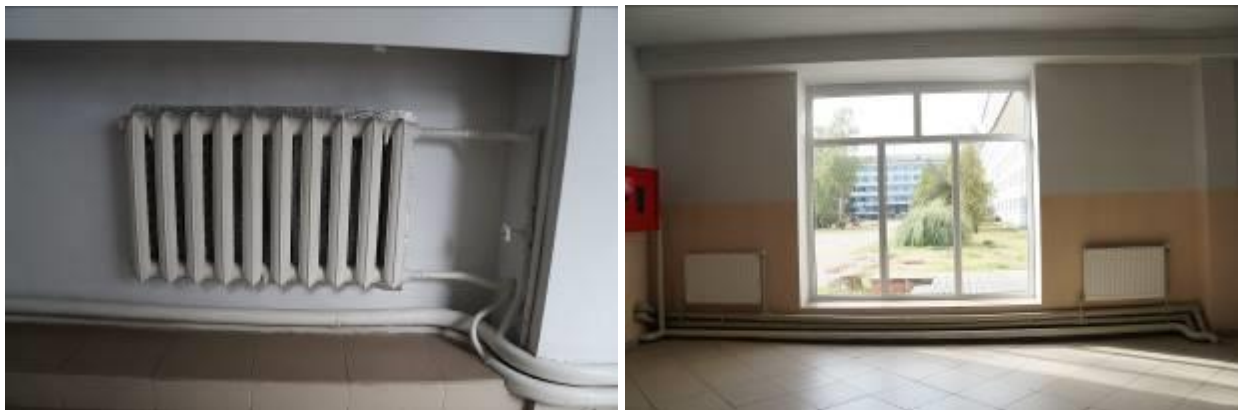
Figure 19 General view of the university space heating system

The general condition of the heating system of IFNTUNG buildings is very different. In some cases, there is a two-pipe system, in another part - one-pipe.

- pipes and radiators of the heating system have high sludge and corrosion wear, which leads to constant heat loss in accidents and creates an additional load on the circulating pumps;

- radiators do not heat up completely, have a large layer of paint, and in some cases need a complete replacement;
- in buildings there is, in some places, an insufficient number, complete absence or various inefficient types of radiators, which leads to underheating of the premises;

- there is a complete or partial imbalance of heating due to an imperfect single-pipe system, which is already slugged and does not have the ability to balance, so it needs some upgrades. In other types of balancing systems, it is not possible due to the lack of balancing valves on radiators and risers;

- in some places the radiators are incorrectly closed by protective screens, which prevents their normal convection and reduces their efficiency by 30-70%;

The existing heating units (radiators) are worn out and are in poor condition. They are affected by corrosion and sediments, reducing their thermal efficiency.

- hydraulic balancing of the heating system (installation of balancing valves),
- replacement of radiators and installation of thermostatic valves, allowing to maintain better the setup indoor temperature in accordance with the actual demand in the building
